# **Volcanic aggregates and alkali-silica reactions in the world: a comparative study with Azores aiming to enhance concrete durability on volcanic oceanic islands**

Tese de Doutoramento

Medeiros, S. (2021). Volcanic aggregates and alkali-silica reactions in the world: a comparative study with Azores aiming to enhance concrete durability on volcanic oceanic islands. Tese de Doutoramento, Faculdade de Ciências e Tecnologia, Universidade dos Açores, Ponta Delgada, Portugal. 412 p.

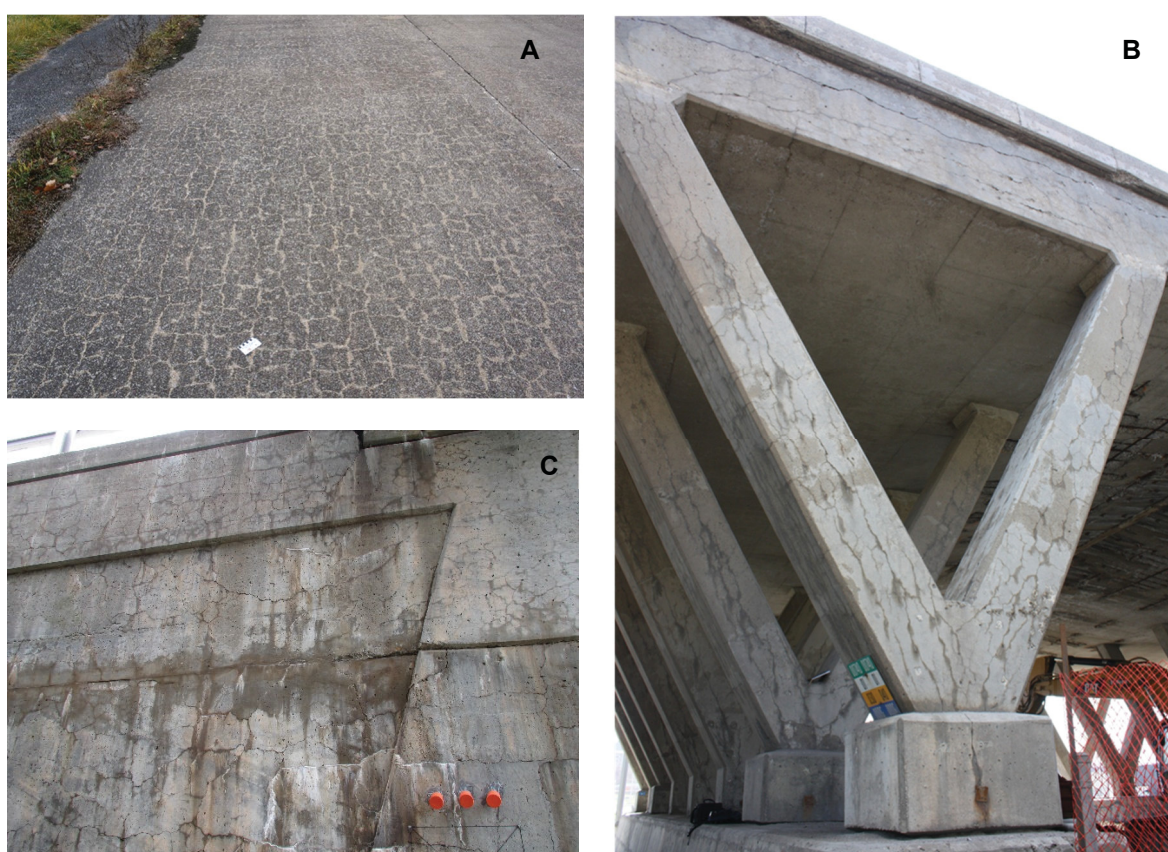
**Figure 2.7.** Patterns of cracking in concrete due to ASR: (A) map-cracking in concrete pavement, (B) Map cracking in the wing wall of a highway bridge structure, and (C) longitudinal cracking following the main reinforcement in columns of a highway concrete structure (with compliments of B. Fournier).

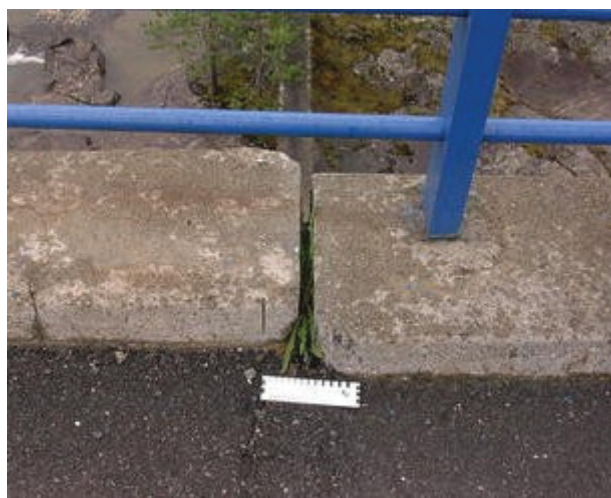
**Figure 2.8.** Misalignment in the crest of a concrete dam due to ASR (Fernandes and Broekmans 2013).

A concrete structure can suffer from movements, displacements and deformations as a result of different causes including expansion due to ASR (Figure 2.8). According to Fournier et al. (2010), the development of ASR in a concrete structure is not homogeneously distributed, varying between or within different parts of the structure as a function of various factors such as: (1) differences in the proportioning and composition of concrete (e.g., concrete obtained by different suppliers and with aggregates containing different reactivity levels, cement of different alkali contents); (2) variations in the exposure conditions and loading regimes between and within the various parts of the structure; (3) differences in the size and geometry of different parts of the structures, (4) variations in the reaction rates between different parts of the structure (due to leaching, dilution, deicing salts, etc.); (5) variations in the structural restraints within and between the different parts of the structure; (6) variations in the age of the different structural members (e.g. structure built in different stages). For example, differential expansion/movement between structural concrete members affected at different rates by ASR can cause a malfunction of the spillway gates in dams, where the operation of machinery can be significantly compromised (ACI, 1998; Fernandes and Broekmans, 2013).

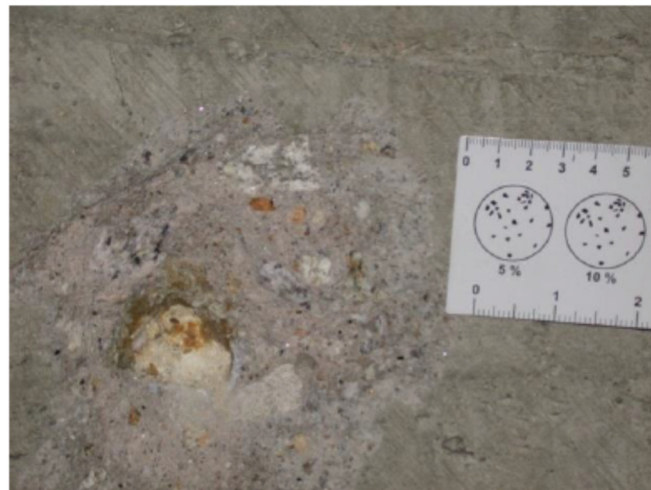
**Figure 2.10.** Example of pop-out in a concrete element (Ramos, 2013).

Pop-outs are also one of the features of ASR, although they are more frequently associated with freezing and thawing action (Thomas et al., 2011). In the case of ASR, pop-out occurs as the result of the expansion of individual reactive aggregate particles, thus forming a hole on the surface of the concrete member and leaving the particle exposed (Figure 2.10). The presence of alkali-silica gel in the pop-out is indicative of ASR (Fernandes and Broekmans, 2013; Owsiak et al., 2015; Poole and Sims, 2016).

The appearance of a pop-out begins with a semi-circular crack and with a vertical displacement of the semi-circular margin. As it progresses, the crack becomes approximately

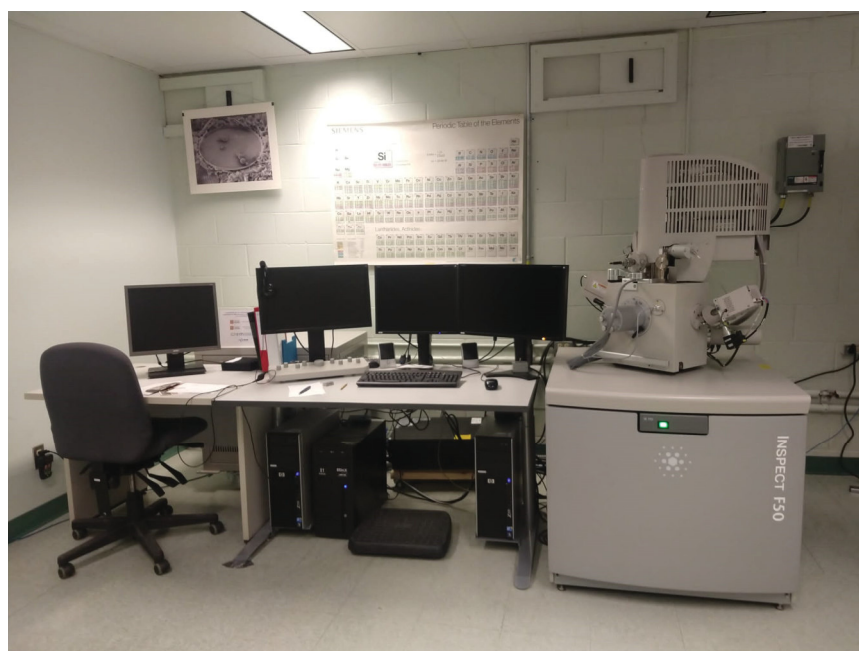
**Figure 4.5.** Scanning electron microscope (Laval University).

SEM has some advantages when compared to the optical microscope (Welton, 2003): (1) the samples are easy to prepare; (2) greater depth of field and resolution are obtained, and (3) a significantly higher magnification range is available (most SEM analyses of rocks involve magnifications between 10x to 20,000x). Nowadays, the magnification of the most modern SEM goes up to 300,000x (Erić, 2017).

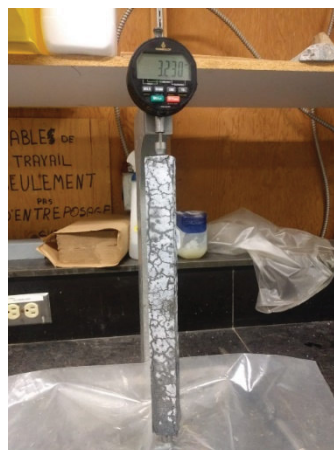
**Figure 4.10.** Measuring the mortar bar of the AMBT method.

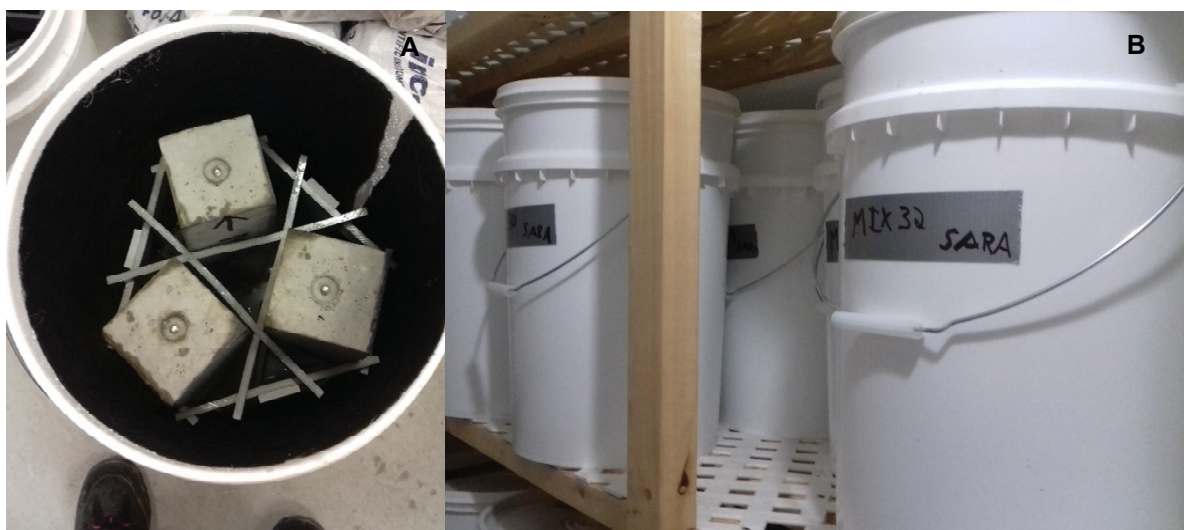
**Figure 4.13.** Plastic container /pails: A) with a wick and 3 prisms inside a rack; B) inside a chamber at 38°C.

- 3) After demolding the first length measurement is recorded (Figure 4.12);
- 4) Then, they are stored above water in a sealed plastic container/pails (with a wick placed around the wall of the container) and placed in a chamber at 38°C for one year (Figure 4.13A and B);
- 5) Measurements are done periodically for up to one year;
- 6) If necessary, the period of time can be prolonged to two years, especially for evaluating the effectiveness of SCMs to prevent expansion due to ASR.

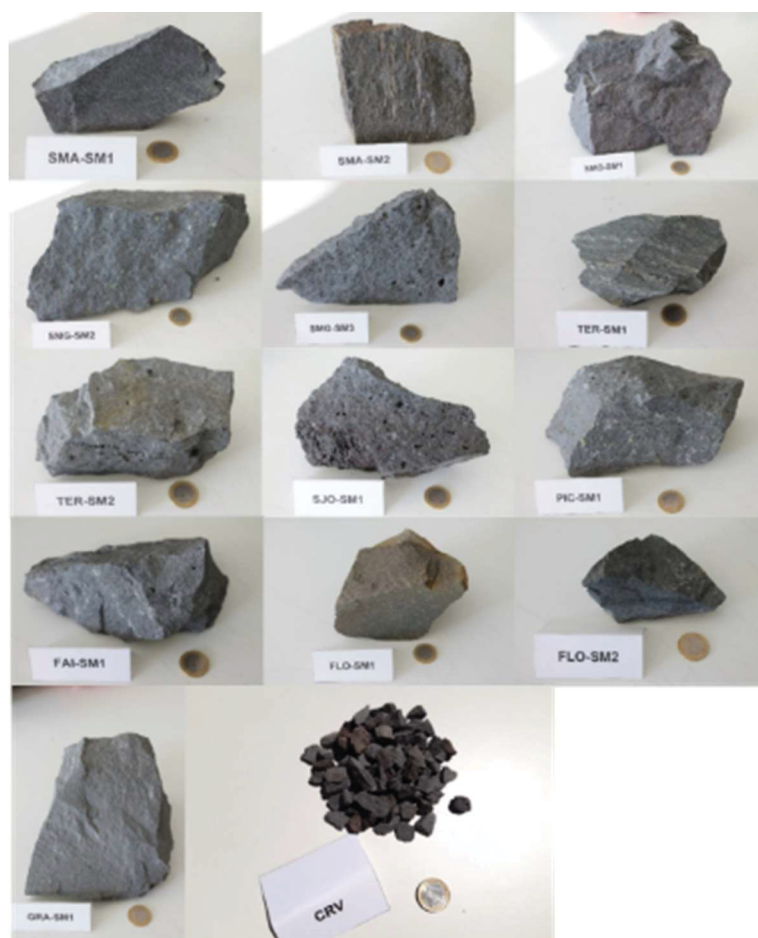
**Figure 5.9.** Block samples of the Azorean rocks were used as aggregates. Only the CRV sample is formed by crushed aggregate.

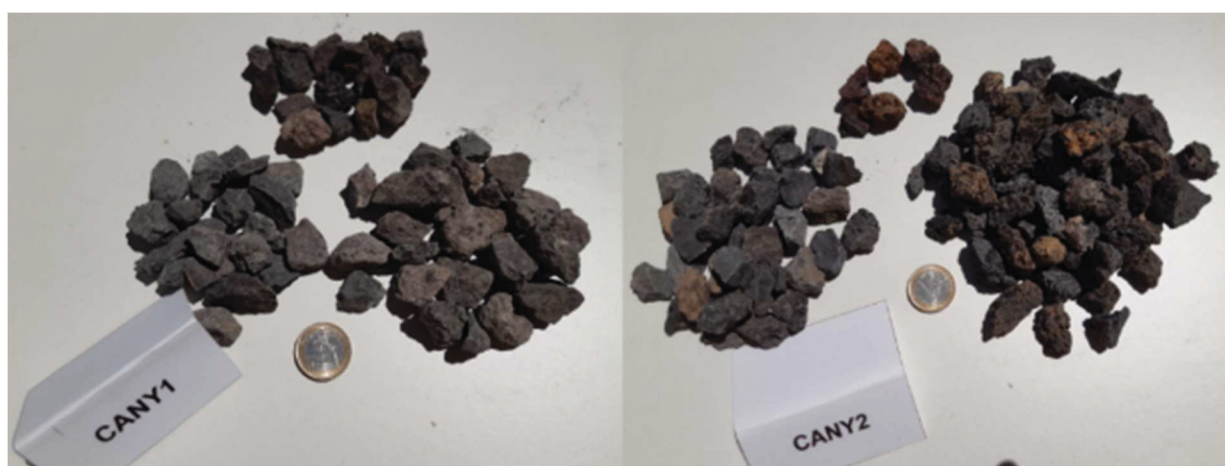
**Figure 5.11.** Canary samples of aggregate in crushed rock are split into different fractions according to the texture and colour.

From the macroscopic point of view, both samples are aphanitic, one is subaphyric with very few phenocrysts of pyroxene (CANY1) and the other contains phenocrysts mainly of olivine and pyroxene and less of plagioclase (CANY2). The samples range in colour from grey to a reddish tone and display either massive or vesicular texture. The shape of the particles of crushed aggregate is elongated with sub-angular grains. Both samples were separated into three fractions each, based on the colour and the texture: almost massive, vesicular and reddish particles (Figure 5.11).

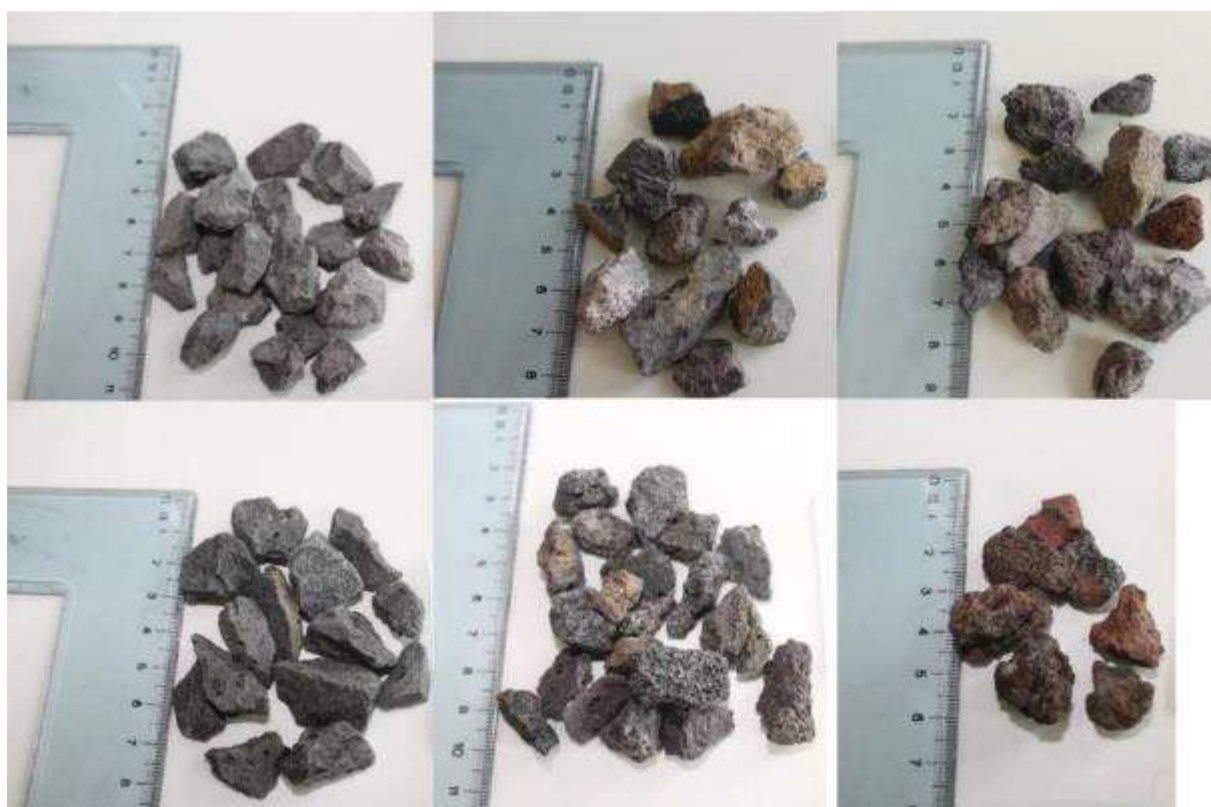
**Figure 5.17.** Macroscopic photos of the different aggregates and facies from Hawaiian aggregates.

Macroscopically, the aggregates from two of the Hawaiian Islands are aphanitic; some contain olivine phenocrysts (HW1, HW2 and HW7), in one there are rare olivine phenocrysts (HW3) while the others are completely aphyric (HW4, HW5 and HW6). The majority of the samples are light grey in colour to a slightly reddish tone but one of the samples is more reddish when compared to the others. They are massive to vesicular with rounded to elongated and subangular particles. The various samples were grouped into different facies: almost massive, vesicular and reddish particles. Figure 5.17 shows the hand sample of each aggregate.

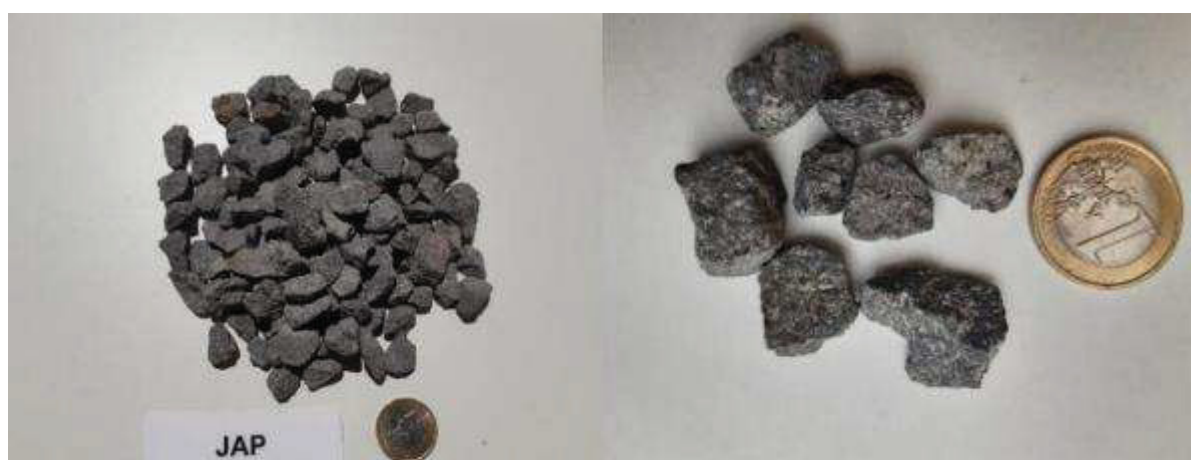
**Figure 5.42.** Macroscopic photos of JAP aggregates: A) general view and B) detailed perspective.

From the macroscopic point of view, the andesite is aphanitic with a light grey colour, although some particles have a reddish tone on some surfaces. In general, the aggregate particles are punctuated mainly by plagioclase white crystals and several dark crystals are also present.

The crushed rock forms subangular aggregate particles with some elongated shapes. Figure 5.42 shows the macroscopic aspect and detail of some of the andesitic aggregate particles.

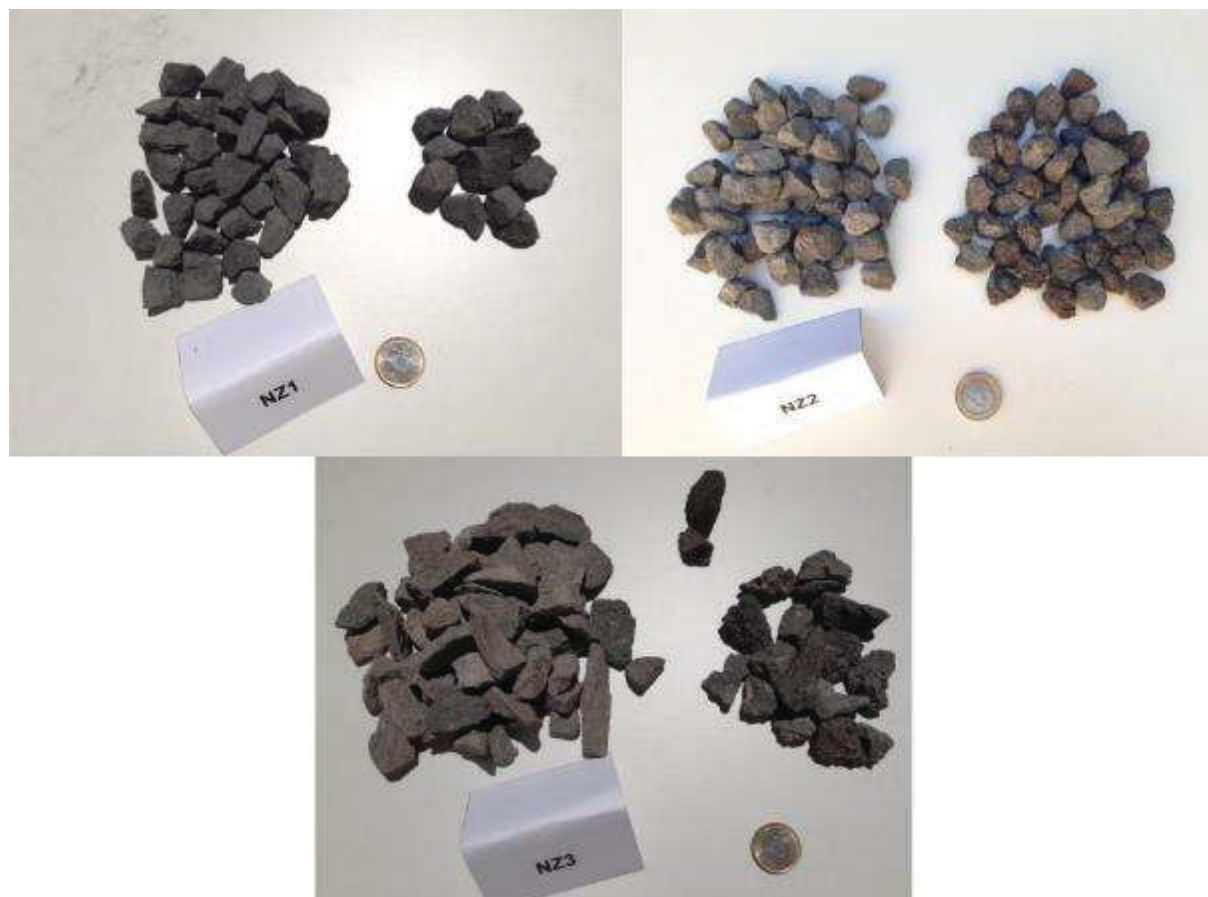
**Figure 5.45.** Macroscopic photos of the different aggregates and facies from New Zealand.

Macroscopically, the aggregate samples from New Zealand are aphanitic with phenocrysts of olivine and some plagioclase. The samples are light grey in colour, but some display a bluer-greyish colour (NZ2). All samples contain aggregate particles with a reddish tone and particles

that are more massive than others. NZ3 sample showed that the majority of the particles are elongated presenting a more subangular form. The three samples were grouped into different fractions based on the texture and colour: quite massive, vesicular and reddish particles (Figure 5.45).

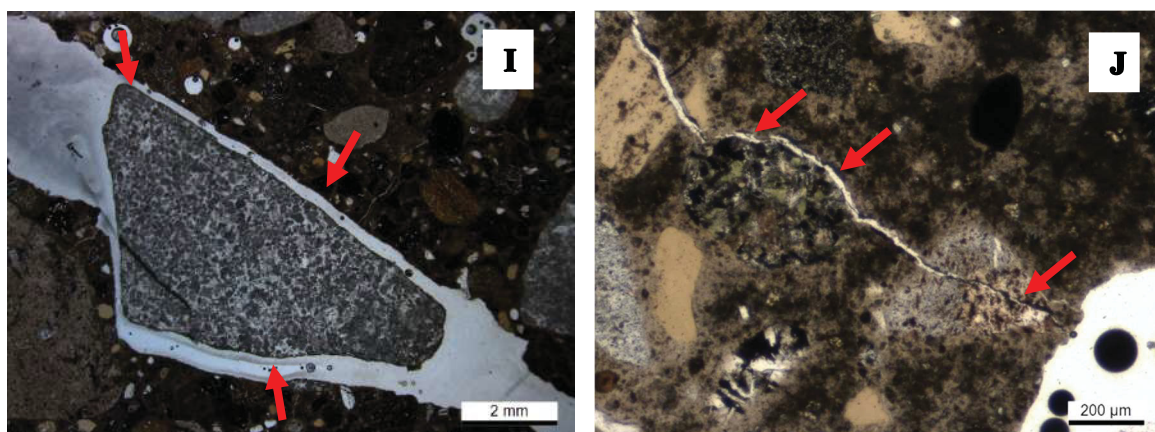
**Figure 5.87 (continued).** Photomicrographs of concrete prisms incorporating Icelandic aggregates. All photos are in PPL. I) Limestone aggregate particle debonded from the cement matrix (ICL4 sand); J) Crack starting in rhyolite aggregate particle and outlining other aggregate particles (ICL4 sand). The red arrows point to the cracks.

In the Icelandic concretes there is no clear evidence for an ongoing ASR, although in some cases it seems that something is happening in the rhyolite aggregate particles and in the darker basalt aggregate particles containing volcanic glass.

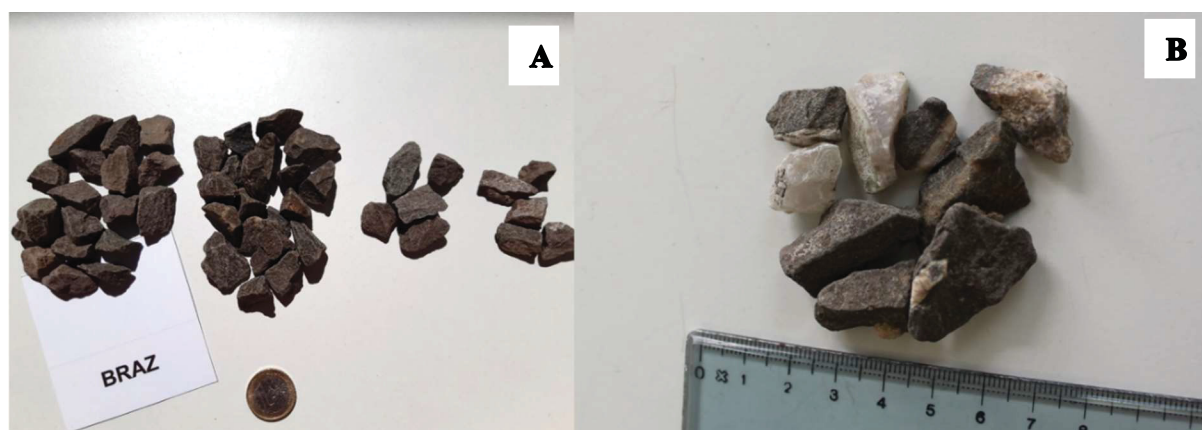
**Figure 5.97.** Macroscopic photos of the BRAZ aggregate divided in different fractions. A) General view; B) detail of the fraction with white particles.

Macroscopically, the crushed aggregate sample from Brazil is aphyric with a brownish-grey colour and sub-angular particles (Figure 5.97A and B). Some of the aggregate particles show a reddish surface, others contain some white material not reactive with HCL and others are whitish particles similar to quartz (Figure 5.97B), which may be part of a silica vein. Figures 5.97 (A and B) show the different fractions and the detail of the one that contains white particles or basaltic particles with a surface with a white material.

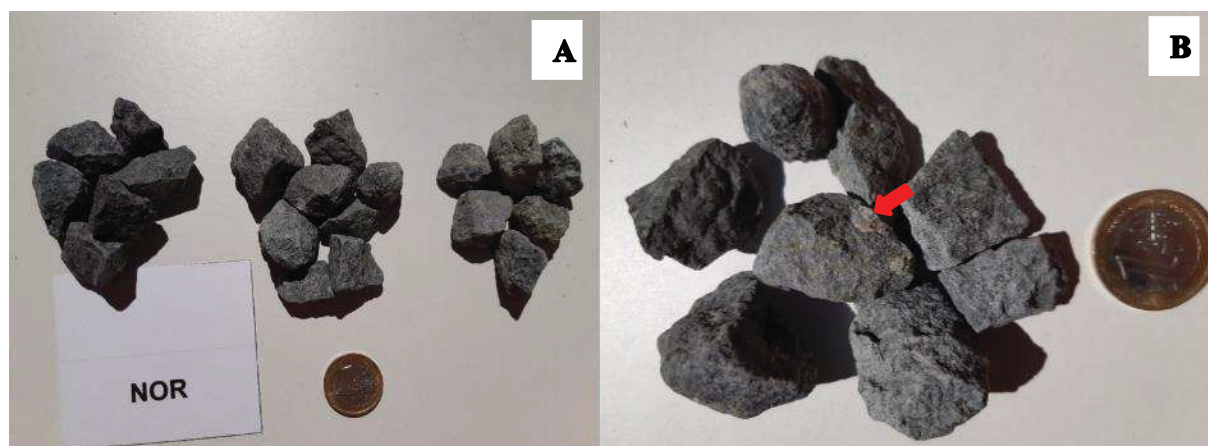
**Figure 5.109.** Macroscopic photos of the NOR aggregate with different fractions: A) General view; B) detail of one of the fractions with white areas (red arrow).

Macroscopically, NOR aggregate sample is aphanitic displaying a grey colour (Figure 5.109). The particles show angular to subangular forms. The aggregate particles are massive with some dark phenocrysts and others show whitish material filling the vesicles. The aggregate samples were separated by fractions based on texture and colour.

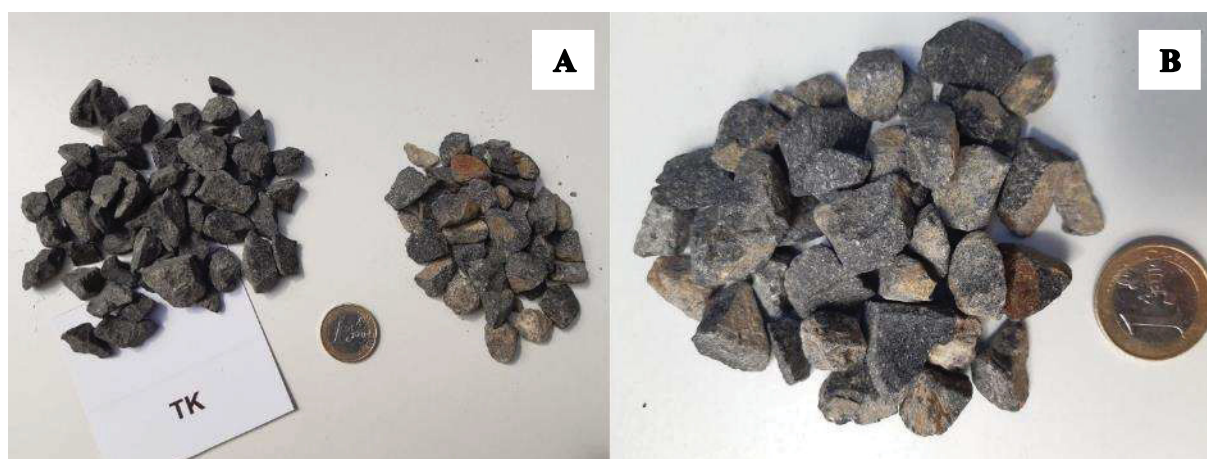
**Figure 5.113.** Macroscopic photos of the TK aggregate with different fractions: A) General view; B) detail of one of the fractions with white dots and the surfaces lined by a beige or red colour material.

Macroscopically, the rock sample from Turkey is aphanitic, mainly with a grey colour; however, some aggregate particles show a greenish tone (Figure 5.113). Half of the aggregate particles show a beige or red colour material on one of the surfaces, and seem to be punctuated by white minerals. Elongated vitreous crystals are visible in different particles. The samples are massive in texture with angular to subangular forms. The aggregate samples were separated by fractions based on texture and colour.
